CAUSES OF CORROSION OF REINFORCING STEEL

SAN MATEO-HAYWARD BRIDGE

IV-S.M,Ala-105-B,A

PART III

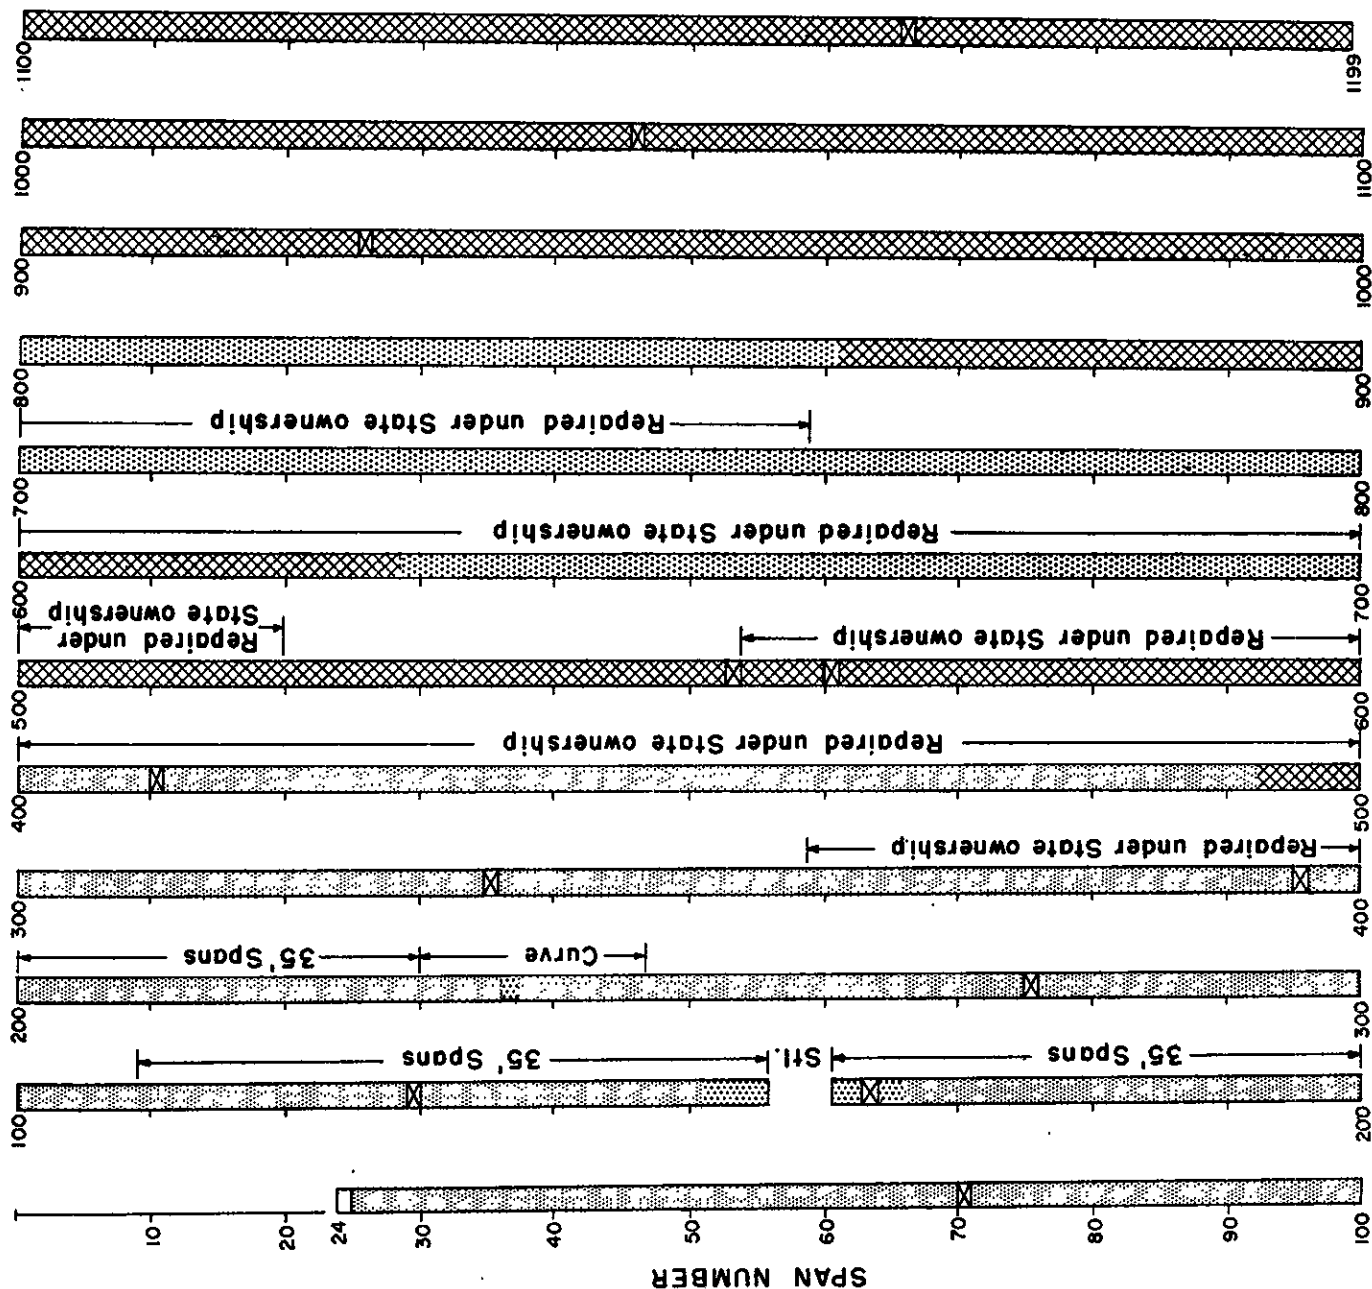
In order to obtain data representative of the structure as a whole, it was necessary to select a sufficient number of spans spaced at intervals over the length of the structure. The bridge consists of 1176 spans numbered from 24 at the west end to 1199 at the east end. Originally it was planned to conduct tests on 20 spans spaced at intervals of about 60 spans. However, limitation of time and funds made it necessary to reduce the program to 13 test spans. Figure 1 is a schematic layout of the bridge indicating the sections that have been repaired under State ownership and the parts of the spans to which a bituminous coating had been applied previously. It is believed that the selection of spans for study is sufficiently broad to include the major variables in design, location and type of previous repair work. Proportionately more spans were selected from the westerly portion of the structure because of a greater variety of conditions and more advanced deterioration.

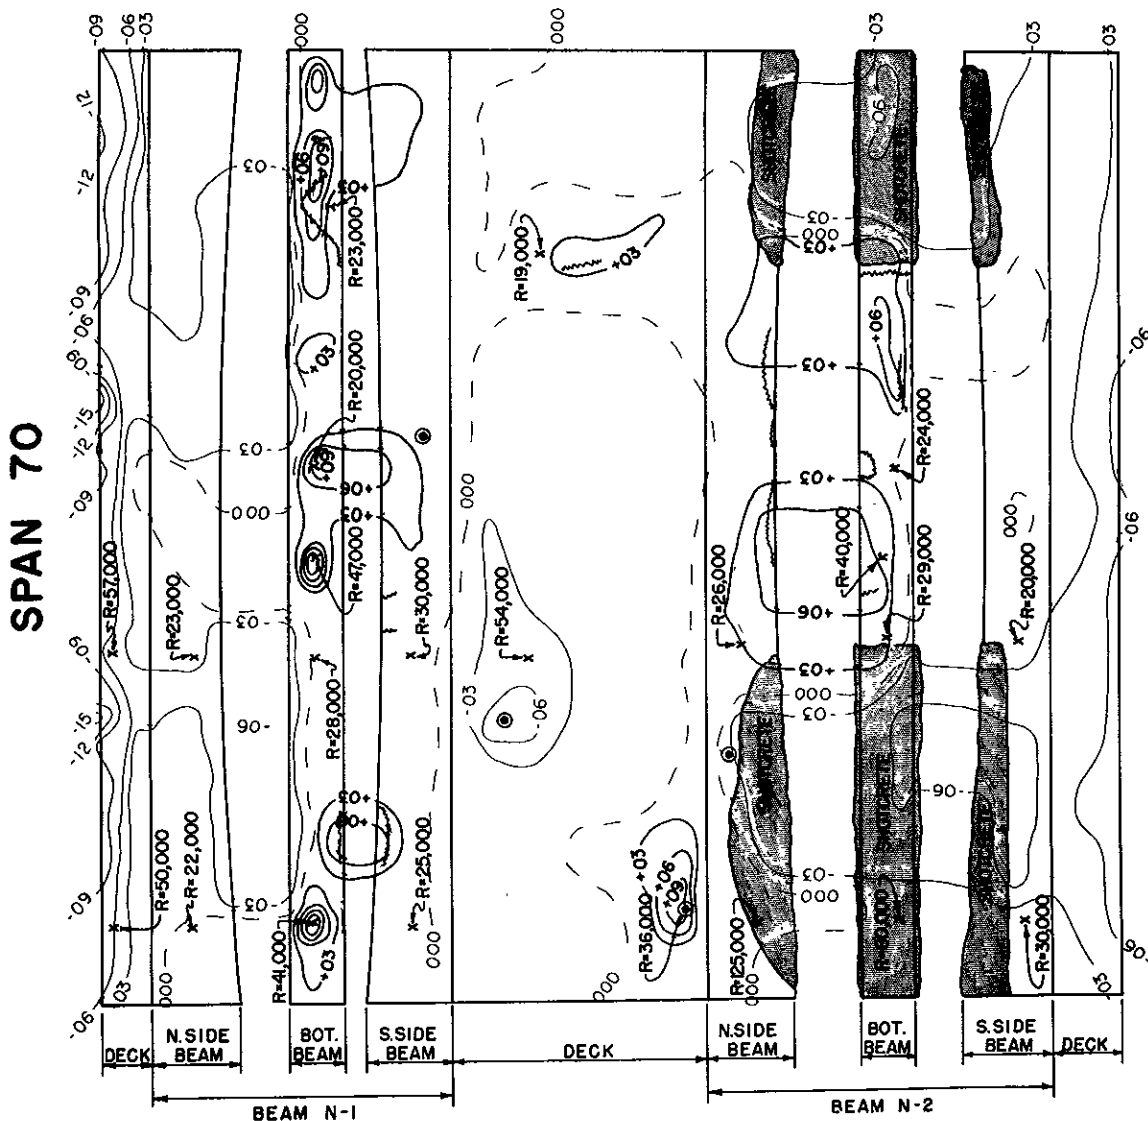
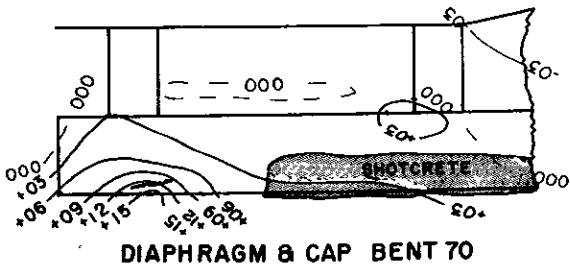
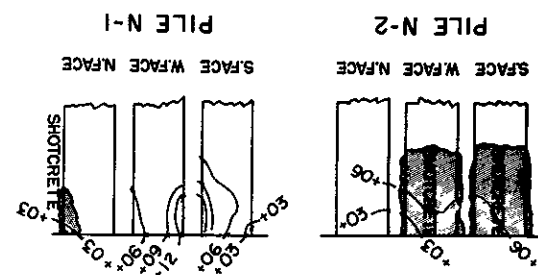
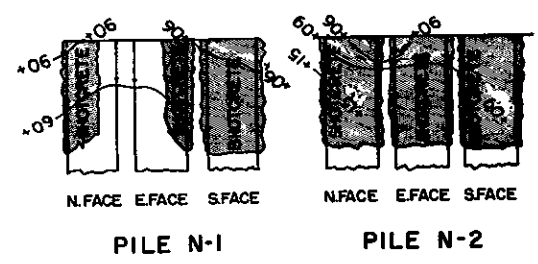
FIGURE 2

Figure 2 represents the conditions found in span 70. About 60 percent of the bottom on one beam was repaired with shotcrete in 1951. Cracks have appeared in the remainder of this beam and also in the adjacent beam. These cracks presumably occurred since the beams were repaired. The equipotential contours indicate the measured electrical potentials. The contours shown in red close around centers of anodic areas (plus) and the green contours close around cathodic areas (minus). The corrosion of the steel occurs in the anodic areas. It will be noted that the steel in repaired areas is now cathodic to the steel in the original concrete. Presumably the steel that is now encased in shotcrete was in an anodic area before the repair. Anodic areas are present at locations adjacent to the shotcrete and elsewhere in the beams where cracking has occurred. Two anodic areas have developed in the deck slab and may be the result of creating cathodic areas with shotcrete or the loss of the previously anodic location. Anodes are present in the caps and piles including portions that have been repaired with shotcrete. The average resistivity of the concrete in the anodic areas is 30,000 ohm-cm and in the cathodic areas, 54,000 ohm-cm.

EQUIPOTENTIAL CONTOURS

SPAN 70

Figures 2, 3 and 4 show equipotential contours in the surface of three spans. They are characteristic of the electrical and physical conditions found in the other spans. The charts present definite evidence of the existence of anodic and cathodic areas within the span and indicate the electrical potential between these areas.

Method (1) is currently being used on the bridge. There is evidence indicated by the corrosion of steel within some of the older shotcrete that this treatment is not necessarily permanent and possibly is detrimental. Although the quality of protection afforded by ideal shotcrete should be excellent, it is difficult to apply it without producing lenses of rebound or otherwise porous material. Such non-uniformity can be productive of differential concentration or aeration cells. Even though the shotcrete affords perfect protection to the steel it encases, its application immediately sets up new conditions within the span that has been partially repaired. The shotcreted section can become cathodic to adjacent areas and cause portions that formerly were neutral or cathodic to become anodes. This action appears to have occurred in span 70 (see Figure 2 and the accompanying discussion).

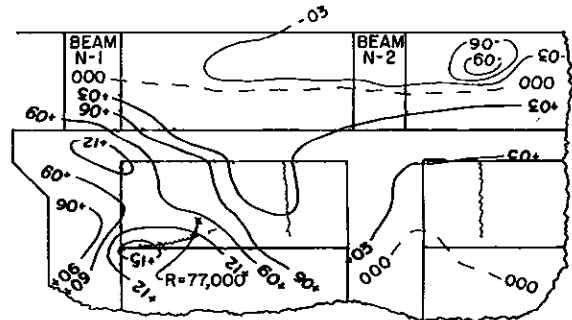
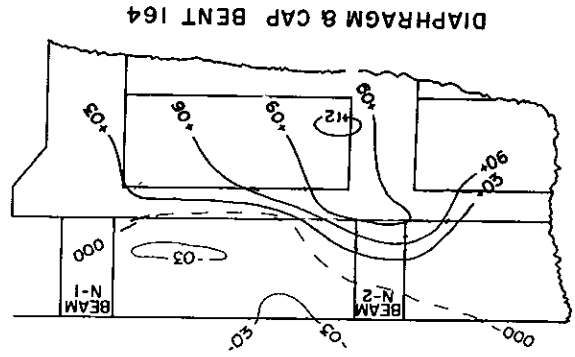
FIGURE 3

Figure 3 represents span 163 which is adjacent to the steel lift span section. Span 163 is at a higher elevation above the bay than other concrete spans. The deck unit is free from longitudinal cracking although there are faint or embryo anodes starting at the ends of one beam. Otherwise, no strong corrosion cells are indicated by the electrical measurements in this deck unit. There are strong anodes in the diaphragms and caps and cracks in the concrete were observed in one diaphragm. The resistivity, measured in cathodic areas averages 76,000 ohm-cm.

EQUIPOTENTIAL CONTOURS

SPAN 163

Span 163 is adjacent to the steel lift span section and is at a higher elevation above the water than is the major portion of the bridge. There is no cracking in the deck unit of this span and the resistivity at the anodic areas was measured at 67,000 ohm-cm. which is the highest value measured in an anodic area in the structure. The span is located near the west or San Mateo end of the bridge where corrosion is most prevalent. It seems probable that its higher elevation above water has resulted in a lower level of contained moisture, thus accounting, partially at least, for its higher resistivity.

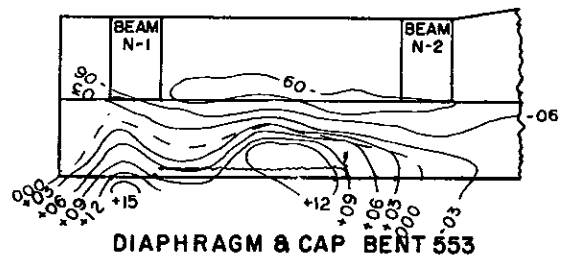
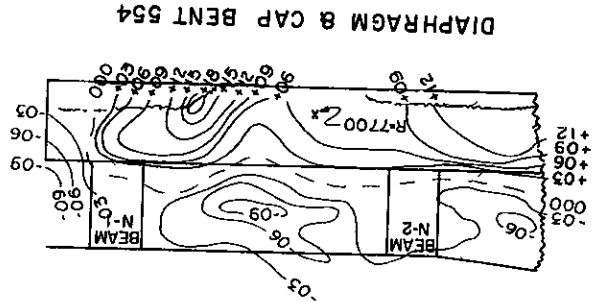
FIGURE 4

Figure 4 depicts span 553 which is representative of a badly deteriorated span that has not been repaired with shotcrete. The field crews observed longitudinal cracks in the concrete covering approximately 50 percent of the length of the underside of the beams. There are strong anodes where cracking has occurred, but elsewhere the beams are neutral or only weakly anodic. The entire deck slab is cathodic. The anodes in the caps appear to be related to the cathodic areas in the diaphragms. The resistivity in anodic areas averages 37,000 ohm-cm and in the cathodic areas, 50,000 ohm-cm.

EQUIPOTENTIAL CONTOURS

SPAN 553

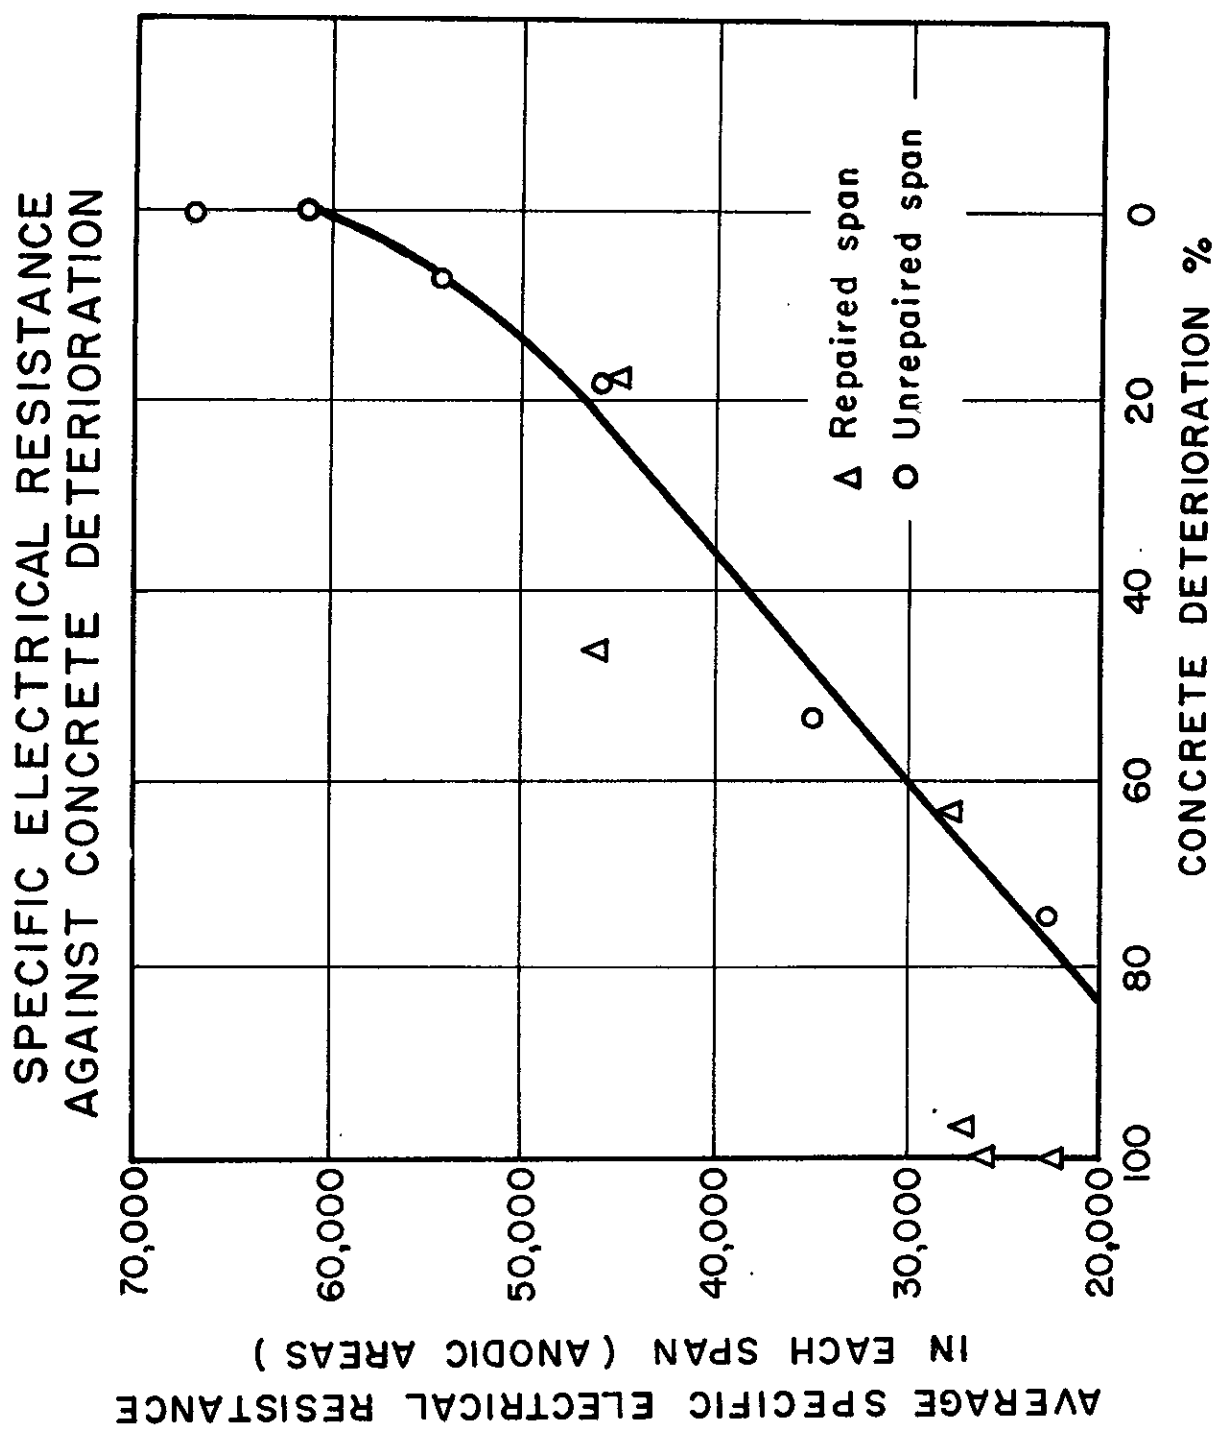
FIGURE 5

Figure 5 is a plot of deterioration against resistivity at anodic areas. The general trend is that increasing resistivity is accompanied by decreasing deterioration. Resistivity of 60,000 ohm-cm is apparently required to inhibit or prevent the start of accelerated corrosion in this concrete.

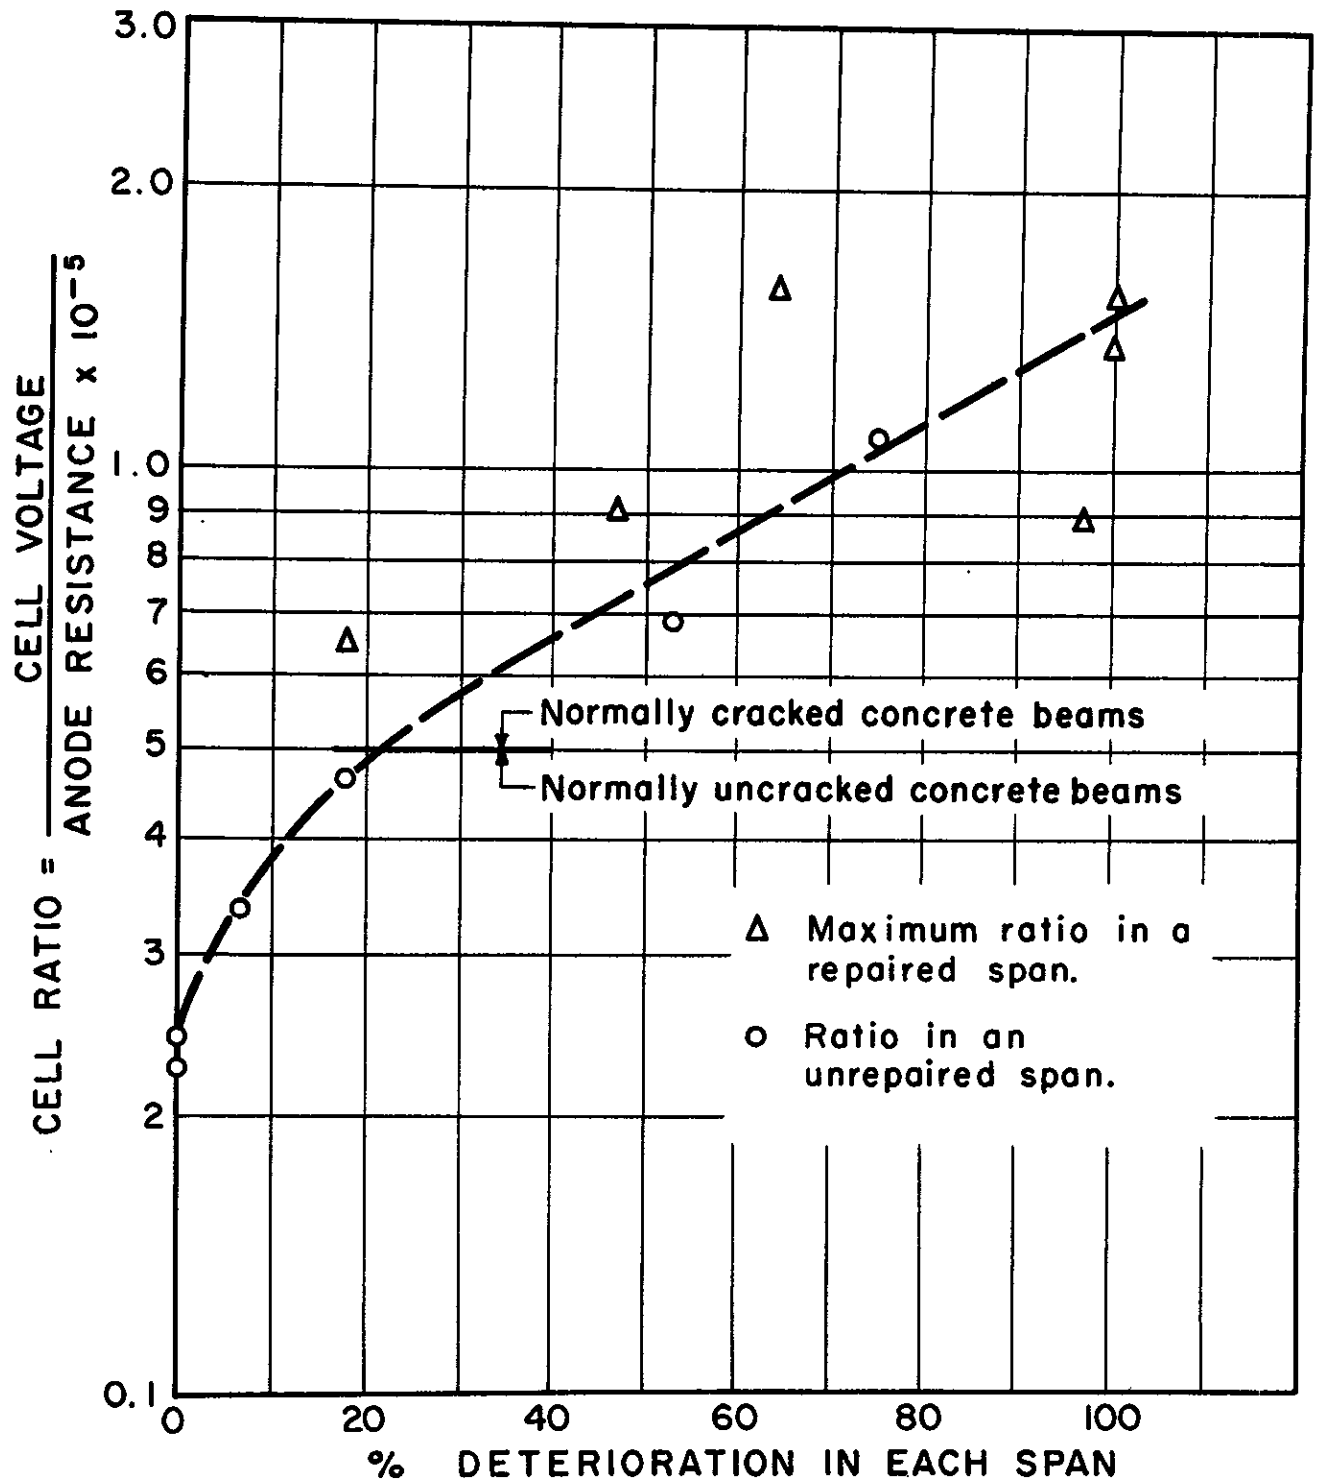
FIGURE 6

The quantity of reinforcing steel corroded is a function of the amount of current (ampere-hours for example) flowing through the corrosion cell. The rate of current flow cannot be accurately measured in this structure but can be represented approximately by the potential difference between anodes and cathodes divided by the resistivity. Figure 6 is a plot of deterioration in the several spans against the ratio $\frac{\text{potential}}{\text{resistivity}}$ which for convenience, has been designated as "cell ratio". The value of potential used in the cell ratio is the maximum voltage differential between the cathode (which is generally in the deck) and the anode (which is generally in a beam). The resistivity value of the concrete used in this ratio was measured at anodic areas. The curve

indicates that there is a definite relationship between the cell ratio and deterioration of the concrete. The curve was determined by the corrosion cells in the deck and beams in the spans under consideration and the shape of the curve may be representative of the deterioration of an average corrosion cell in the bridge. As the curve was drawn from average values, it does not necessarily represent any single cell, but may represent the combined effect of all the cells in a particular span.

CORROSION CELL RATIO AGAINST CONCRETE DETERIORATION

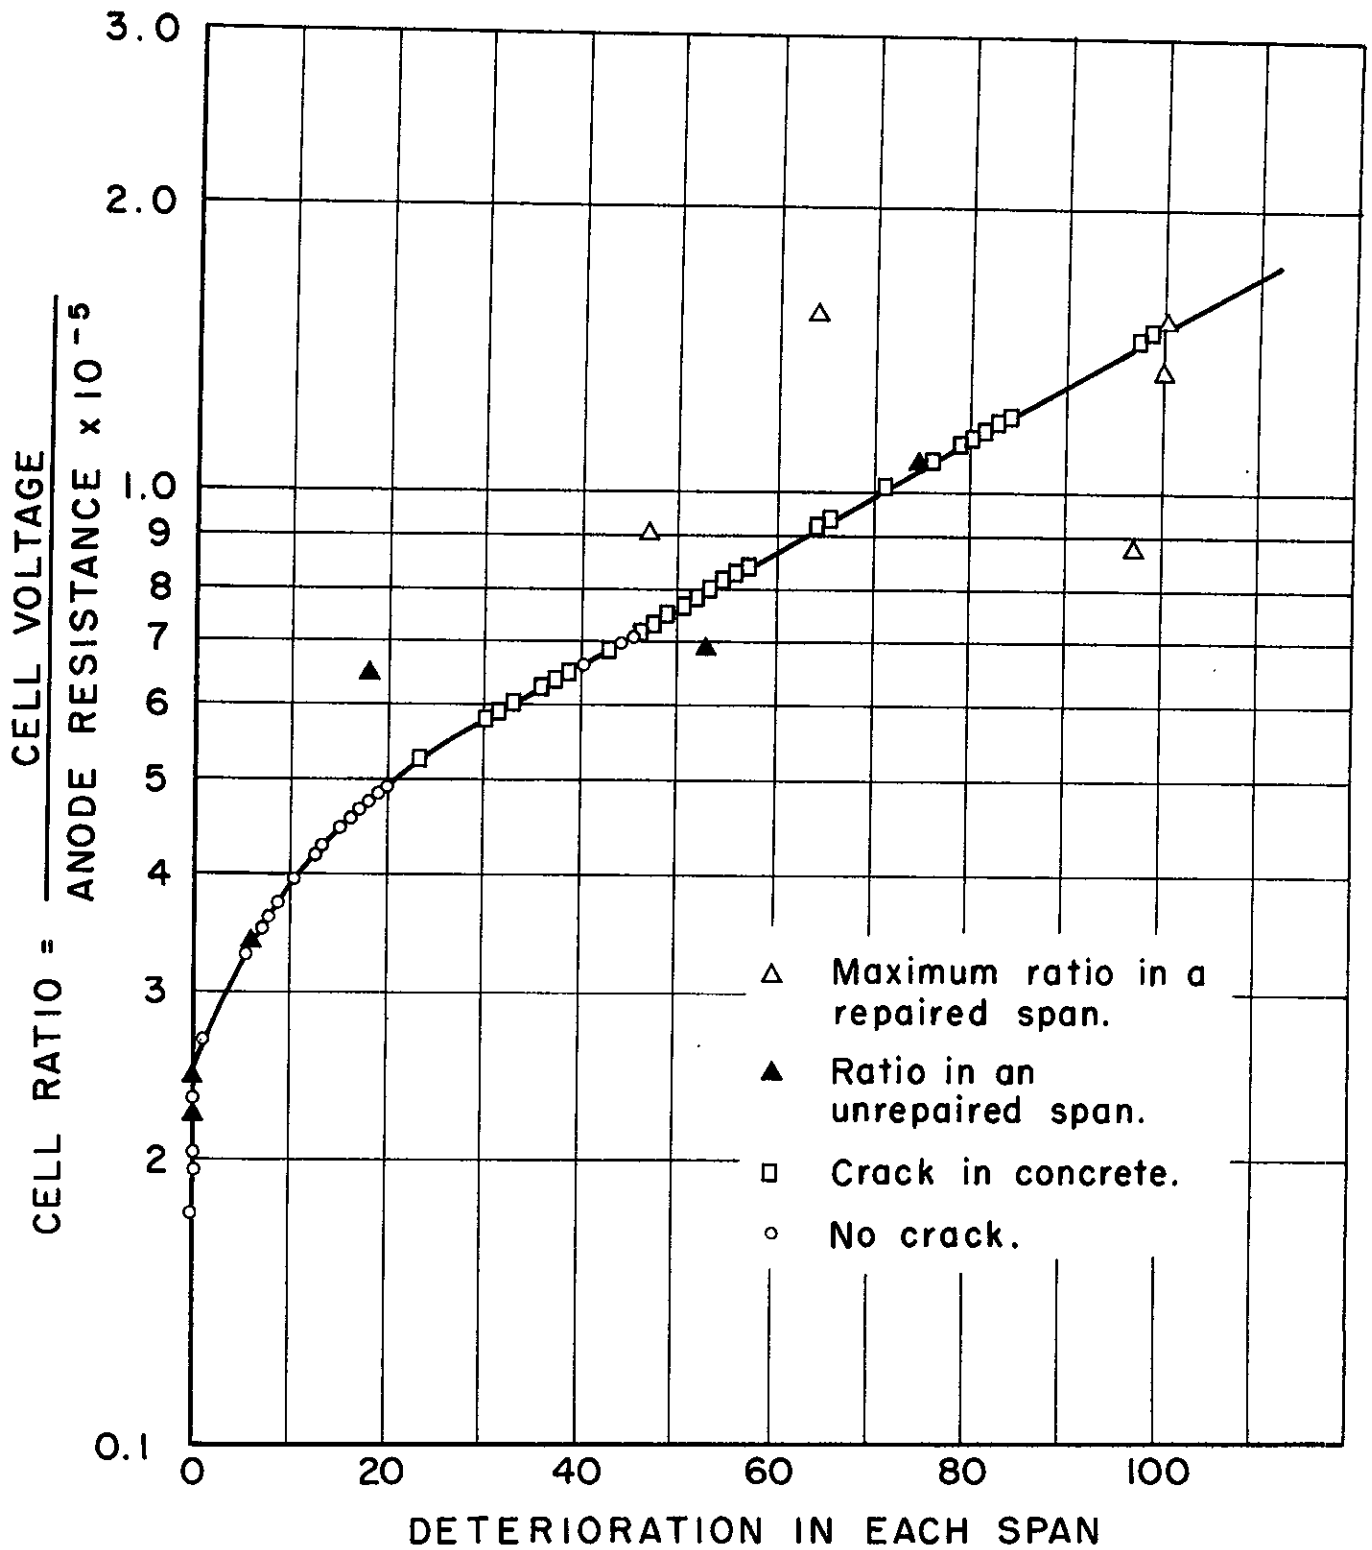
FIGURE 7

Figure 7 is similar to Figure 6 but consideration is given to each plotted point as to whether or not a crack has developed in the concrete. Each point is plotted on the curve according to its cell ratio value. On this chart the circles indicate that there is no crack in the concrete. The squares show that there is a crack. The plotted points do not indicate any particular degree of deterioration other than the presence or absence of cracks in the concrete. It is interesting to note that the division between cracked and uncracked concrete on the curve is about at the 20 percent deterioration point and that the cell ratio at this point is about 0.5. This value is representative of present conditions. It is conceivable that in time cracking will occur under lower cell ratios.

CONCRETE CRACKING AGAINST CORROSION CELL RATIO

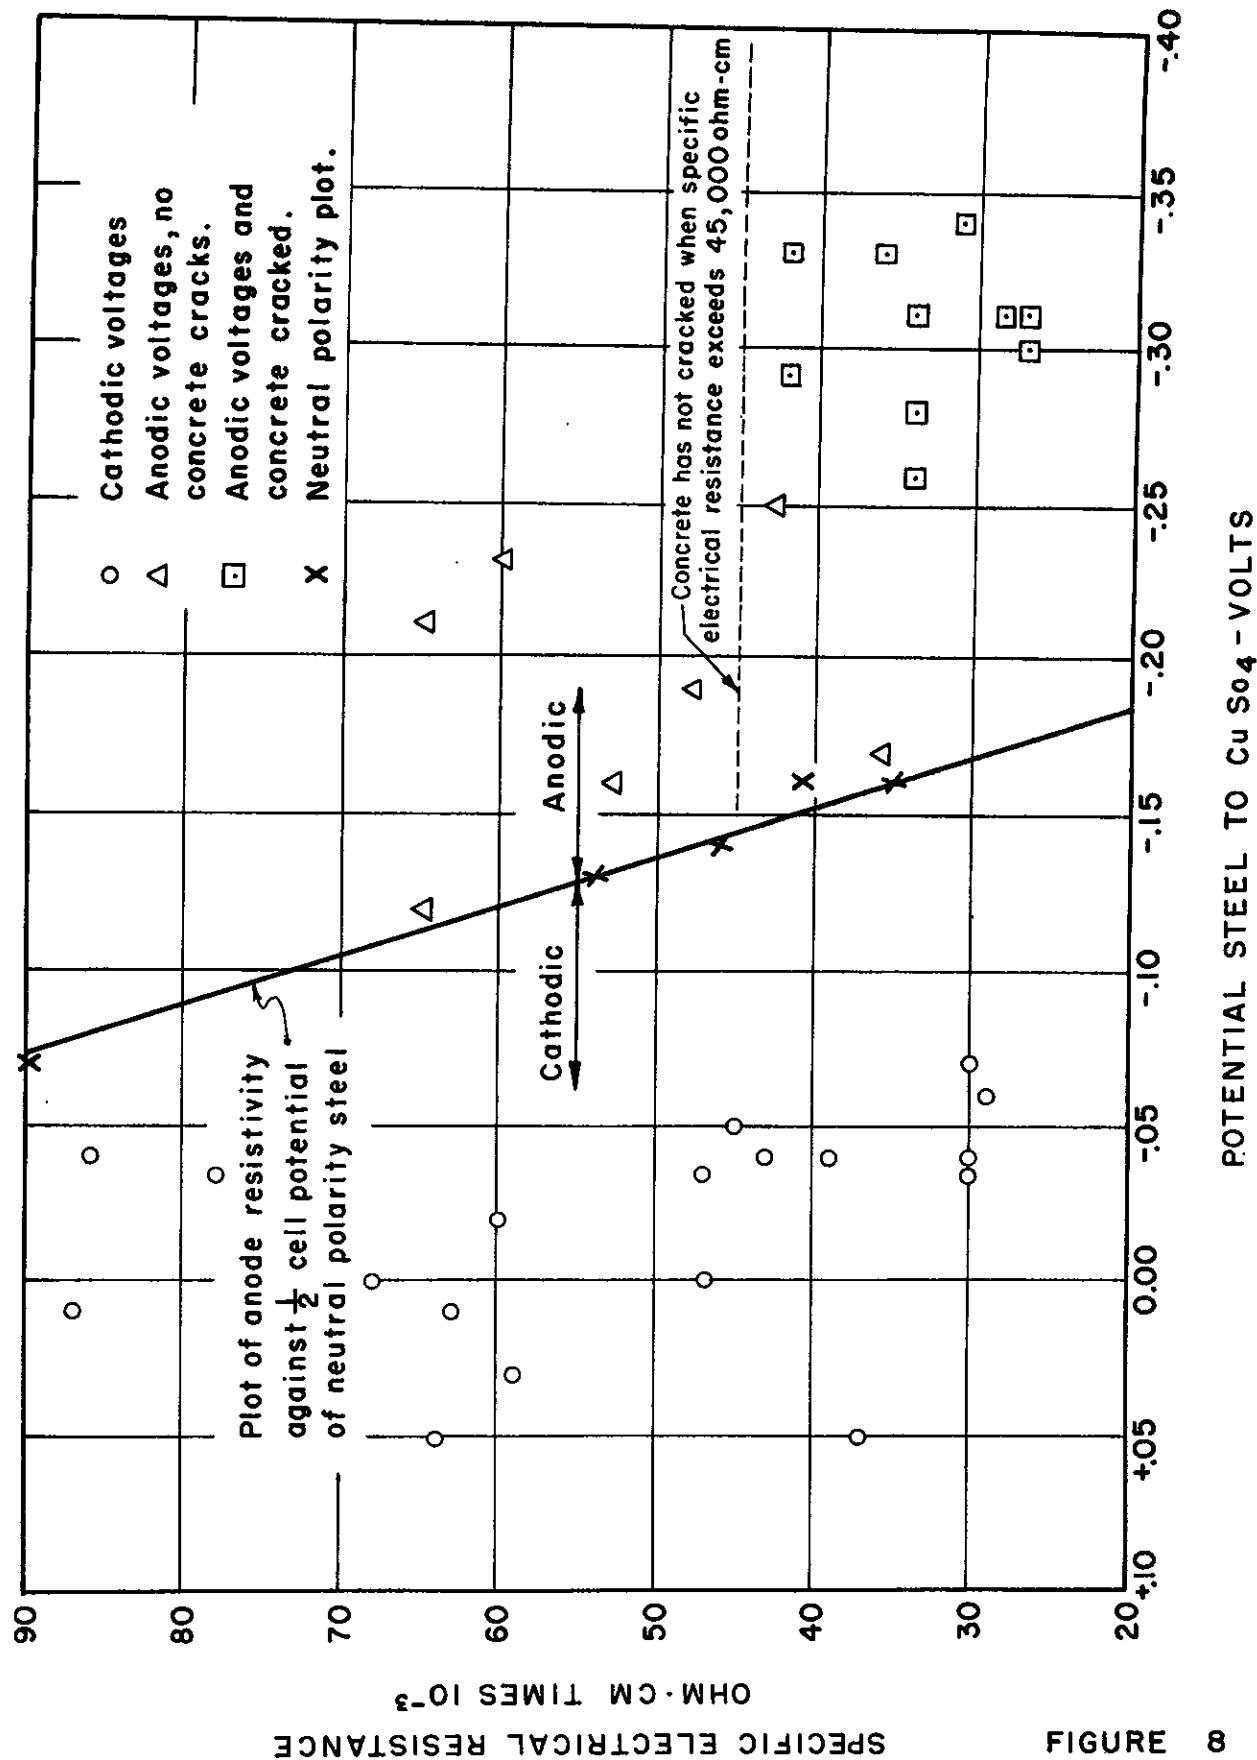
FIGURE 8

In some of the spans potentials were measured by direct connection to the reinforcing steel. In others the measurements were related to a fixed potential point on the surface of the concrete. In the later case, differences in potential were measured and the contours were plotted. The observed potential relative to steel was not known when this method was used. Five of the spans were in the first category and Figure 8 is presented to illustrate the relationships obtained in these spans. The crosses in this figure represent the apparent neutral $1/2$ cell potential of the steel to a copper sulphate reference cell. The sloping line represents the neutral potential of the steel for varying amounts of resistivity (specific electrical resistance of the concrete) as determined by the position of the crosses. Cathodic potentials fall to the left of the curve and anodic potentials to the right. Plotted circles represent cathodic potentials. Triangles are anodic potentials at locations where the concrete was not cracked and squares, anodic potentials in cracked concrete.

The chart shows that cracking in these spans occurred only when the anode resistivity was below 45,000 ohm-cm. but that there are two points where the resistivity was this low but in uncracked concrete. The difference in behavior seems to be related to the excess in the negative potential from the neutral point of the steel. A chart of this kind may be useful in indicating the needed potential for cathodic protection when applied to each corrosion cell.

This chart also indicates that corrosion cells may be set up when reinforcing steel is embedded in concrete of varying resistivity. This is indicated by the fact that in the plotted cells the average resistivity of the concrete in cathodic areas is 64,000 ohm-cm. and only 42,000 ohm-cm. in anodic areas.

$\frac{1}{2}$ CELL POTENTIAL OF STEEL AGAINST RESISTIVITY OF CONCRETE

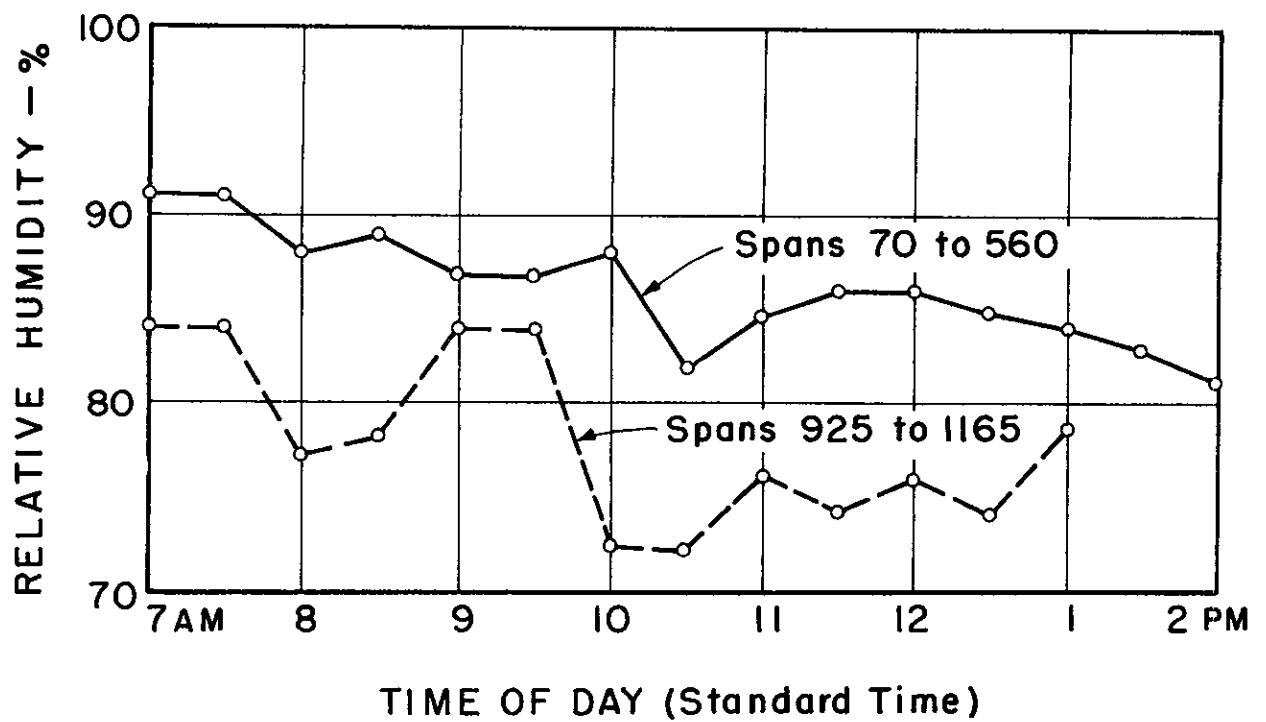
FIGURE 9

The relative humidity of the air beneath a particular span was measured at intervals during the days that the laboratory crews were working at that location. Average results of humidity observations are shown in Figure 9. Two curves are plotted, one for measurements during July, August and September in spans 70 to 560 at the west end, and the other for measurements during October at spans 925 to 1165 at the east end. The average relative humidity at the east end is 9 percentage points lower than that at the west end.

RELATIVE HUMIDITY UNDER BRIDGE
AND SHADED FROM SUNLIGHT. JULY-OCT. 1955

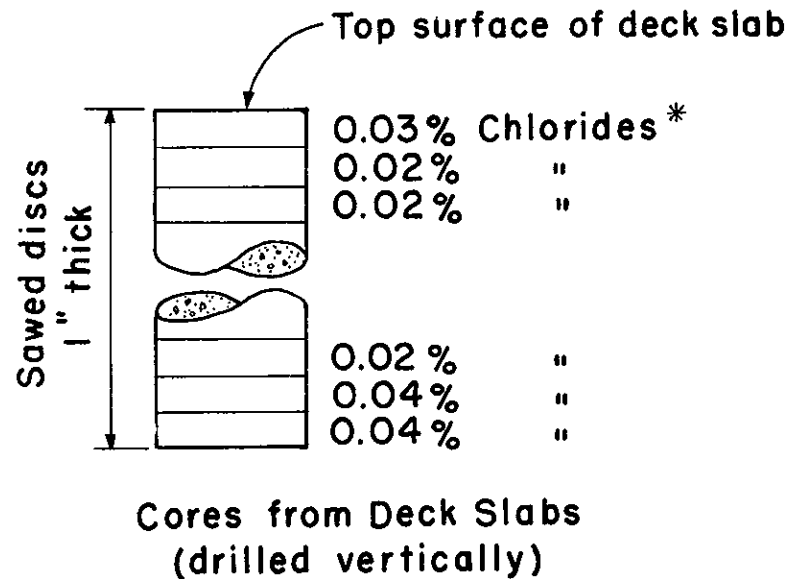
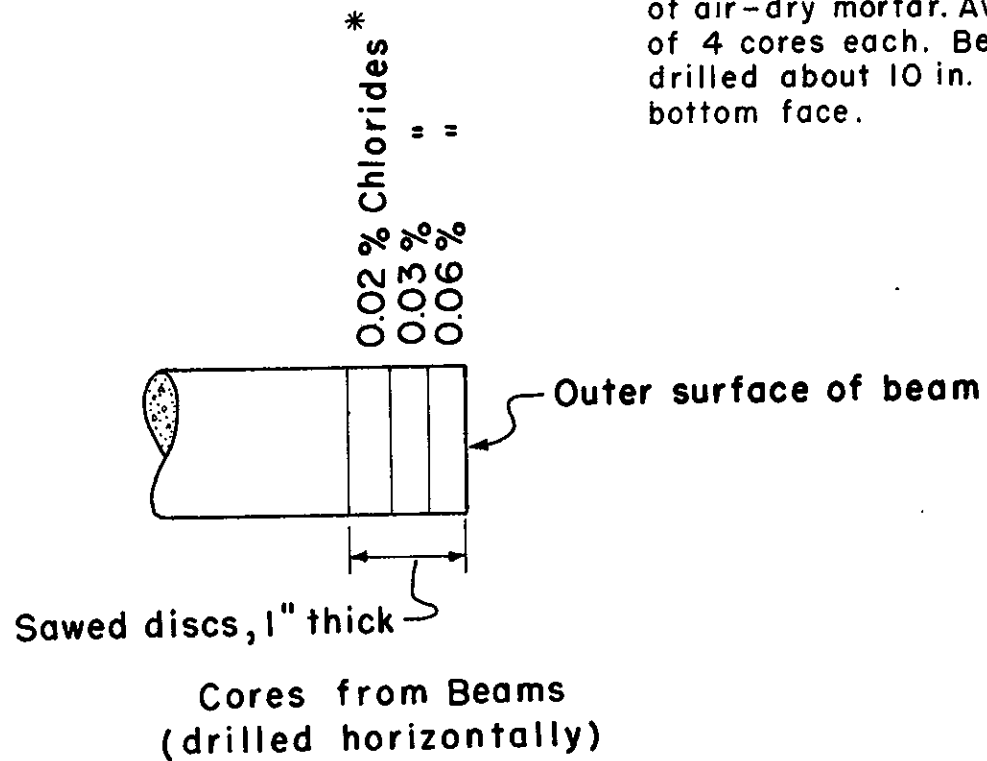
FIGURE 10

The effect of salt content (chlorides) on resistivity is not well established by the test data at hand. The beam cores in which chlorides were determined were taken at points about 10 inches above the lower face and were not at the locations of cracked or severely anodic concrete. The percentage of chlorides as shown in Tables I and II, as previously reported in Part I have been found to vary over a considerable range, even in adjacent sections from the same core. Figure 10 shows the variation in chloride content with depth from the surface of the member as determined in cores from two spans.

DISTRIBUTION OF CHLORIDES IN CORES FROM SPANS 70 AND 129

* % Chlorides by weight of air-dry mortar. Average of 4 cores each. Beam cores drilled about 10 in. above bottom face.
